Manhole Inspection Summary

Manhole # S15AA_036MH

Location Address: **930 CLAYMONT AVE**

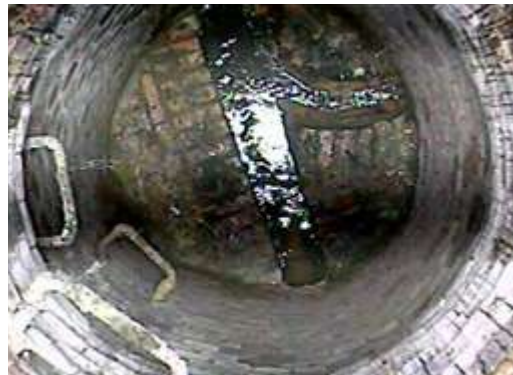
Defect 2

Count: **5** Missing: **0** ☒ **Corroded**

CORRODED STEPS

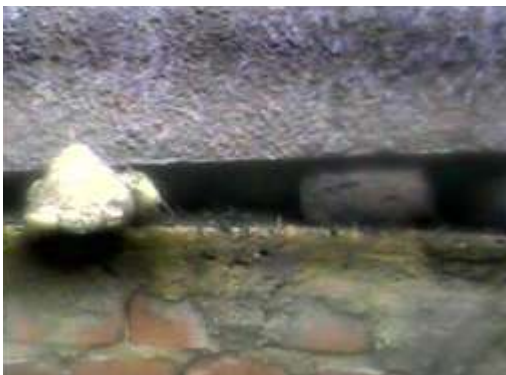
Defect 1

Condition: ☐ Sound ☐ Cracked ☐ Root Intrusion ☒ **Loose Brick** ☐ Deteriorated

FRAME ADJUSTMENT/CHIMNEY
LOOKSE BRICKS

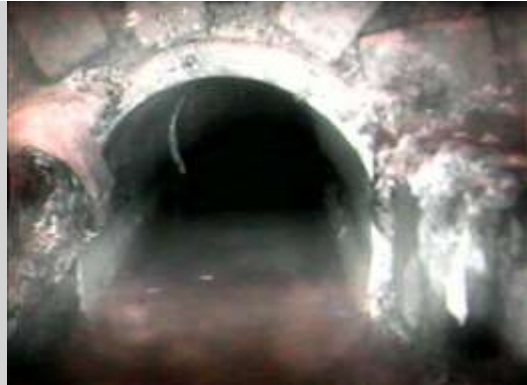
12 O'Clock Outflow

8 in. Circular Gravity Sewer
Pipe Out @ 12 O'Clock

Infiltration: **None** Pipe Seal Cond: **Sound**

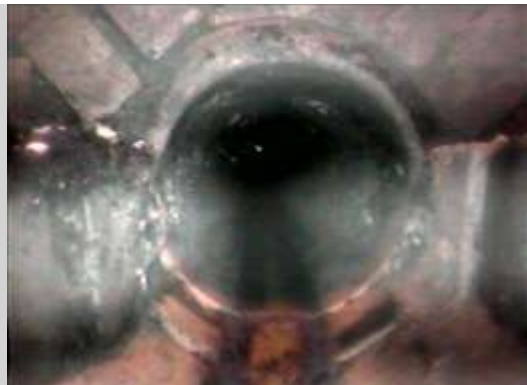
3 O'Clock Inflow

8 in. Circular Gravity Sewer
Pipe In @ 3 O'Clock

Infiltration: **None** Pipe Seal Cond: **Sound**

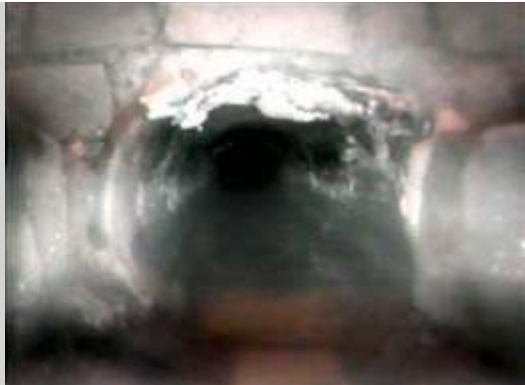
6 O'Clock Inflow

Deposits: ☐ None ☐ Mud ☐ Sludge ☒ **Debris** ☒ **Grease**

Silt Depth: **2** (in.) Deposits Extent: **Light**

Infiltration: **None** Pipe Seal Cond: **Unknown**
